**Initial Investigation of the Cause of Salinisation  
of Dam Water Supplies and their Management,  
at the Bodhinyana Buddhist Monastery,  
Serpentine, WA.**

**A Report**

**Report on Visit to Bodhinyana Buddhist Monastery, Kingsbury Drive,  
Serpentine**

**21Jan98**

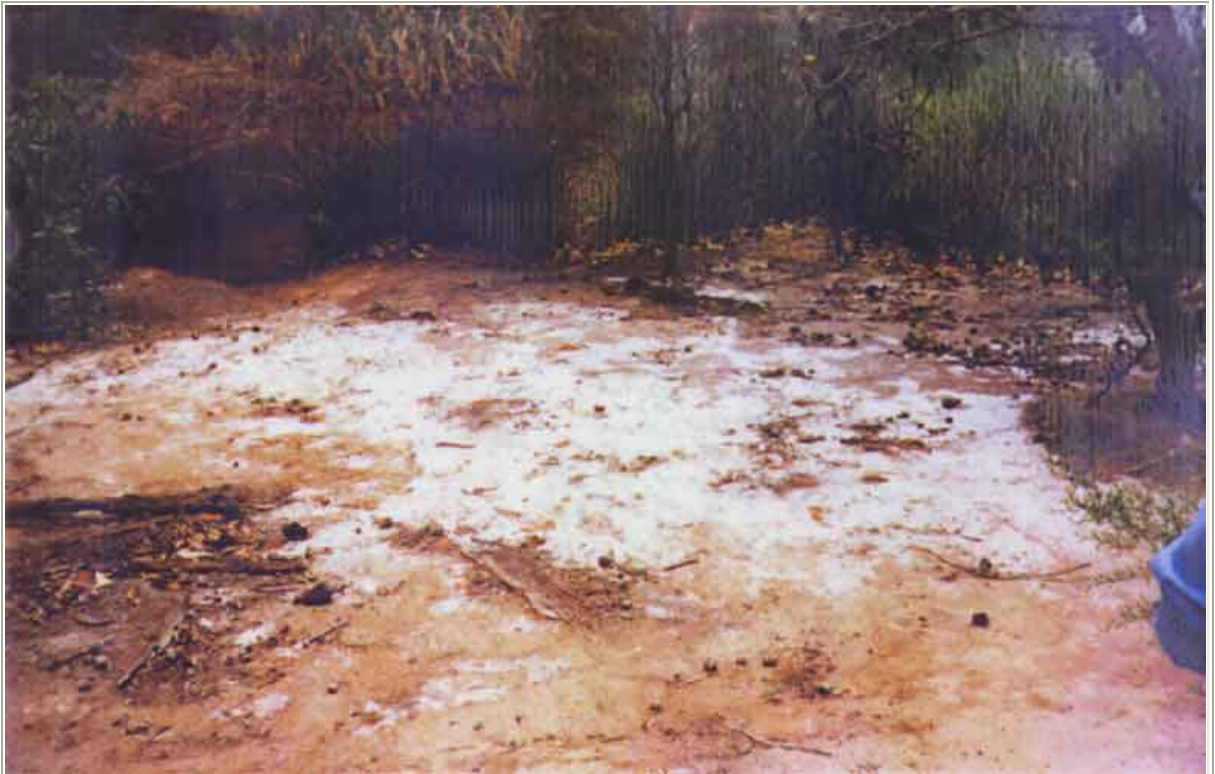
As the salinity issue will be inevitably linked to groundwater flow into the dams and groundwater discharge at the soil surface, indications of seepage were sought. Signs of seepage into Top Dam were found immediately up-slope of the present water level in the dam, with areas of salt inflorescence observed (see Salt Scald below). Reeds, usually associated with areas of groundwater discharge, were also present. There was an exposure of granite rock associated with the wall of Top Dam suggesting that there could be a granite rock bar across the valley which would act as a barrier to

groundwater flow in the valley at the location of Top Dam. This would explain the groundwater discharge at the surface at the dam location. Middle Dam was located on an area known to be a wet seepage area. To the south-east of the dam an area of moist dark coloured soil was observed which identified an area of groundwater seepage. There was no information available, and no wells or dug holes available, to determine the salinity of the groundwater in any of the observed seepage locations.

Salt  
Scald  
above  
the Top  
Dam  
Looking  
East

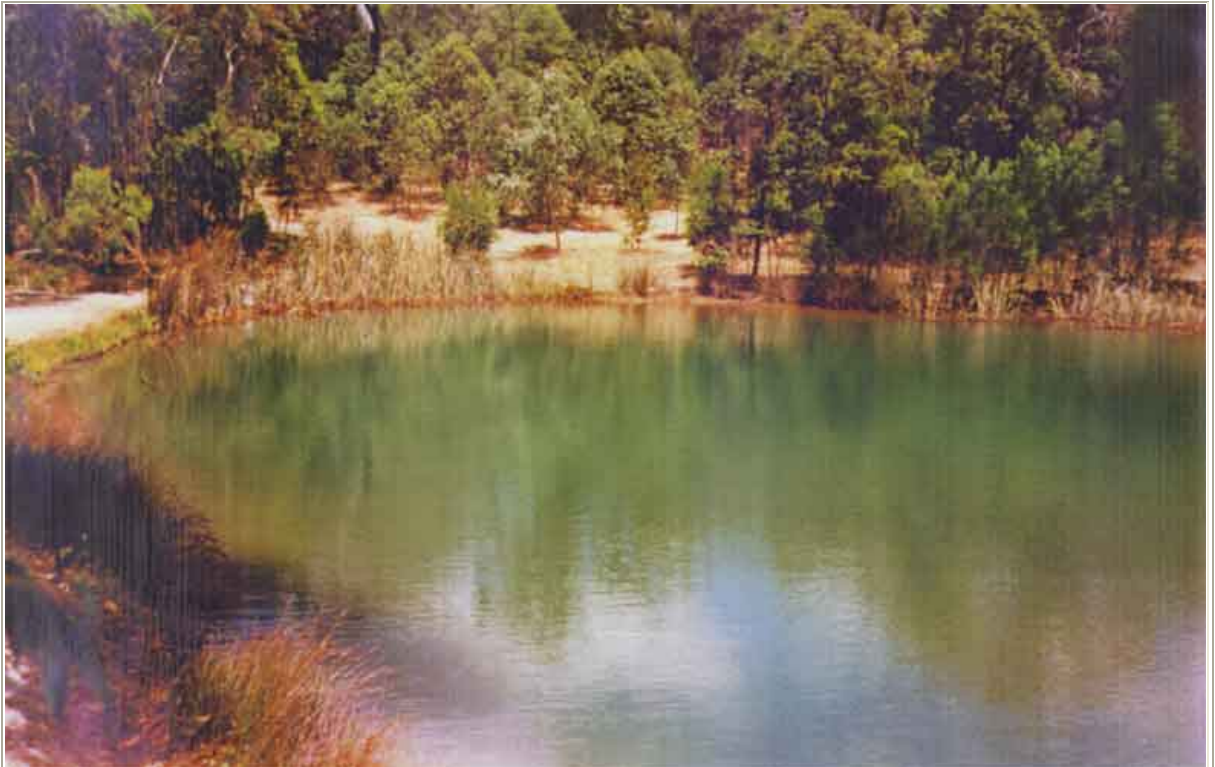
**3.2 Dams:** The Top Dam (see I on Figure 1 and picture below) existed when the property was acquired for the monastery in 1983. The Middle Dam (II on Figure 1), downslope but adjacent to Top Dam, was constructed by the Monastery in April 1993 to receive the winter overflow from the Top Dam. It has been observed that the water level in the Top Dam does not appear to decline as might be expected as water is removed.

Top  
Dam  
Looking  
East

4.3 The observation of the fairly constant water level in Top Dam suggests that there is a significant volume of groundwater seeping into the dam. This would carry salt into the dam and allow an increase in salinity following the refilling of the dam with runoff water during the winter months. Evaporation would contribute to the increase in salinity, but with a smaller impact than the seepage of saline groundwater into the dam.

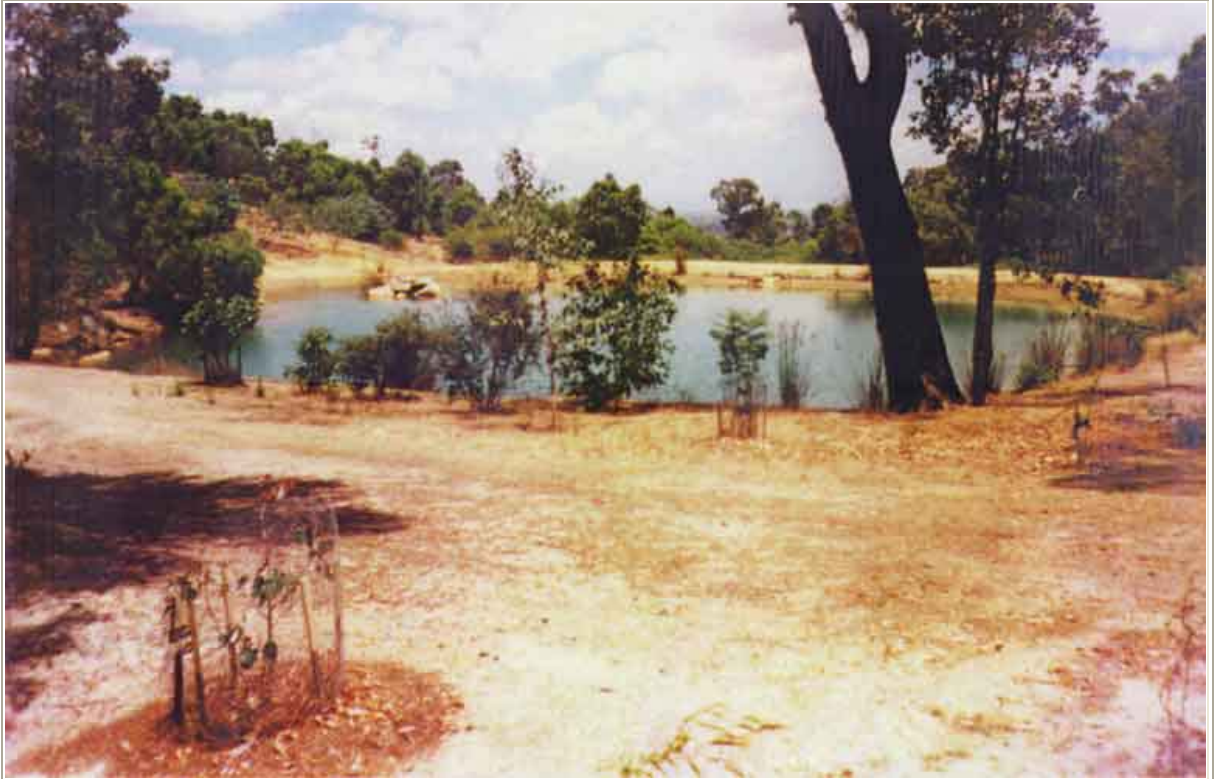
Middle  
Dam  
Looking  
West

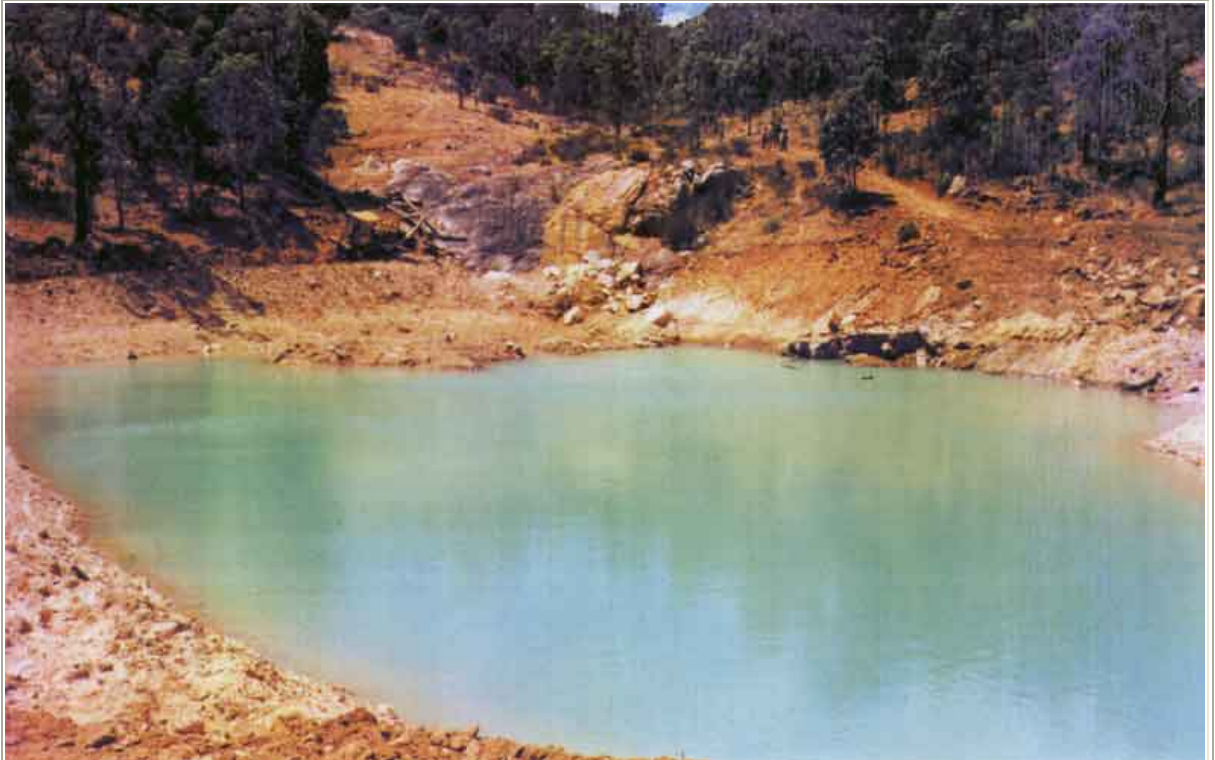
Bottom Dam is a new dam built in June/July 1997 about 200 metres down the valley from Top Dam and Middle Dam. Within a fortnight of completion of construction the dam filled to overflowing. The site has a vertical granite face on the northern side into which the earthen wall of the dam is butted. As would be expected there is seepage coming from the interface of the dam wall and the granite face. On the eastern side of the dam there is another vertical granite face above the level of the dam where flow in the creek forms a waterfall into the dam. Problems with scouring during overflow of the dam are being attended to, and further earthworks undertaken to correct the problem of inaccurate levels at the top of the dam wall. It was recommended that a concrete and rock spillway be designed and constructed to handle the overflow from this dam and to avoid the potential damage to the dam wall by scouring during overflow. Professional engineering advice should be sought on this matter to avoid a catastrophe.

Bottom  
Dam  
Looking  
East
